ABI LLC (Advanced Building Inspectors)  
495 Blue Hill Ave  
Boston MA 02121  
617.442.8000  
info@advancedbuildinginspectors.com

## Confidential Inspection Report

June 26, 2026

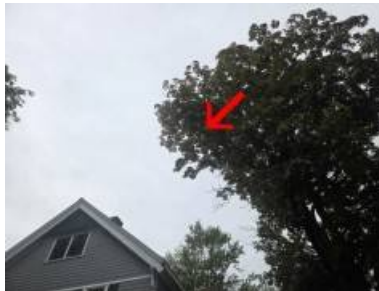
Issues: Tree limbs are overhanging the roof surface and should be trimmed. Moss, mildew and/or mold growth noted. Consult a contractor for further evaluation and repair/replacement.

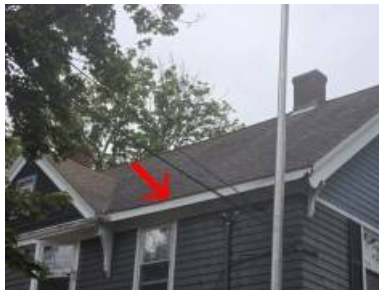
Issues: Consider installing gutters and downspouts to help with site drainage. Consult a contractor for further evaluation and repair/replacement.

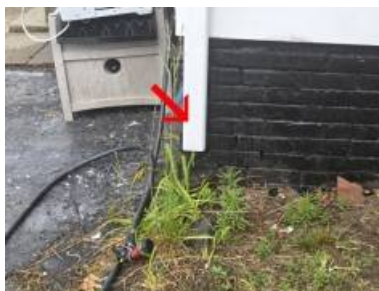
Issues: Extend downspouts to route rainwater away from the building. Gutters are discharging water near the foundation. Consult a contractor for further evaluation and repair/replacement.

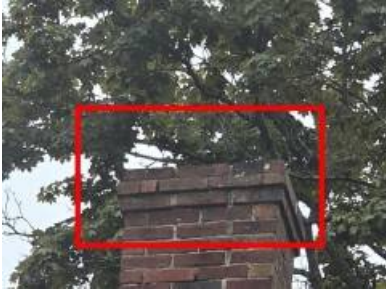
Issues: Chimney needs repair of the following deficiencies: Deteriorated mortar joints are noted. Re-pointing needed, Consult a chimney technician for further evaluation and repair/replacement.

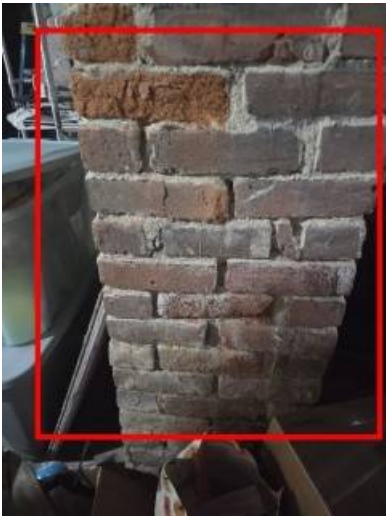
Issues: Chimney needs repair of the following deficiencies: Deteriorated mortar joints are noted. Re-pointing needed, The chimney shows evidence of brick spalling. This condition must be addressed before further damage results. Cause is generally due to moisture getting into the bricks. This is a result of missing or cracked mortar. Consult a contractor for further evaluation and repair/replacement.

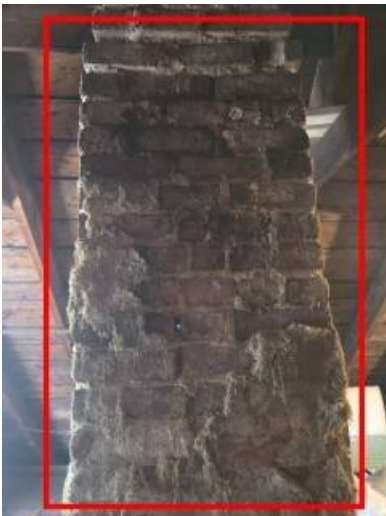
Issues: Chimney needs repair of the following deficiencies: The chimney shows evidence of brick spalling. This condition must be addressed before further damage results. Cause is generally due to moisture getting into the bricks. This is a result of missing or cracked mortar. Consult a contractor for further evaluation and repair/replacement.

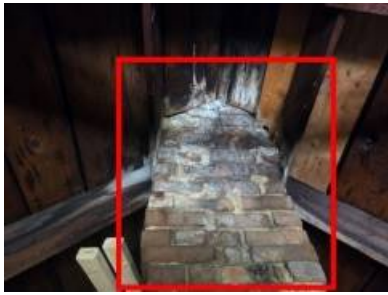
Issues: Signs of water penetration. Chimney needs repair of the following deficiencies: Deteriorated mortar joints are noted. Re-pointing needed Consult a roofer for further evaluation and repair/replacement.

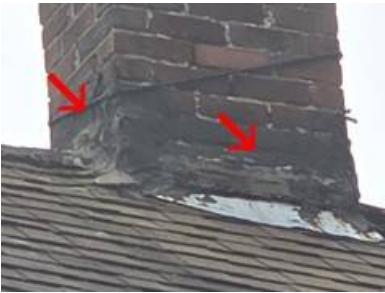
Issues: Tar was used as flashing around chimney. Tar is temporary fix and can lead to future leaks. Consult a chimney technician for further evaluation and repair/replacement.

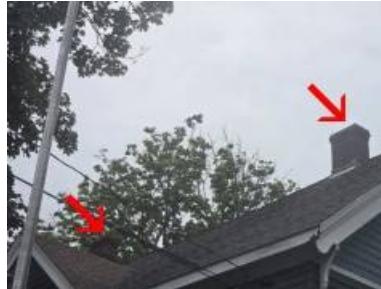
Issues: There is no chimney cap installed. Installation of a chimney cap is highly recommended to prevent water from entering the masonry stack or entering the wood chase causing deterioration.

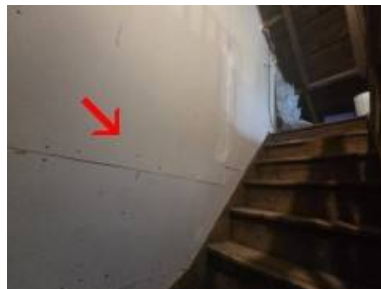
Issues: There is no handrail installed. Consult a contractor for further evaluation and repair/replacement.

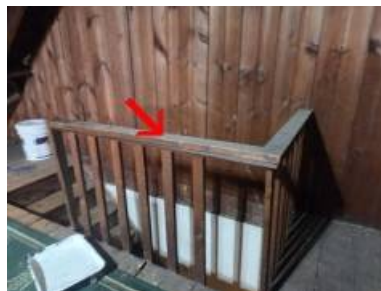
Issues: Handrail is too low. Consult a contractor for further evaluation and repair/replacement.

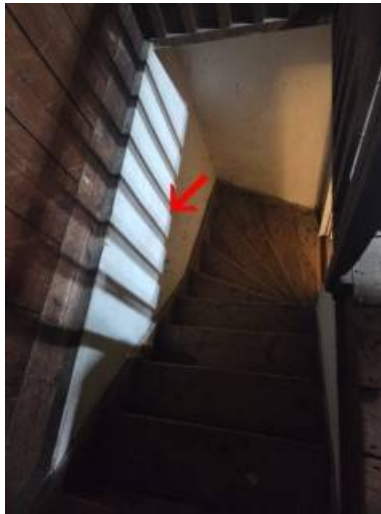
Issues: There is no handrail installed. Consult a contractor for further evaluation and repair/replacement.

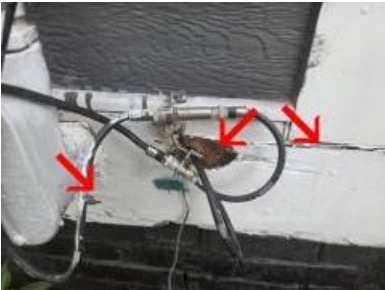
Location: Front, Issues: Water damage noted. Consult a contractor for further evaluation and repair/replacement.

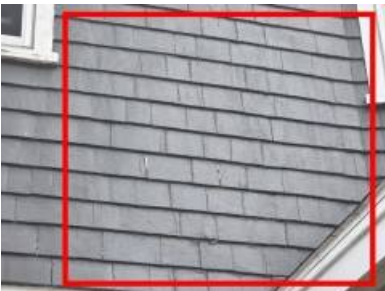
Issues: Peeling paint on siding noted. Consult a contractor for further evaluation and repair/replacement.

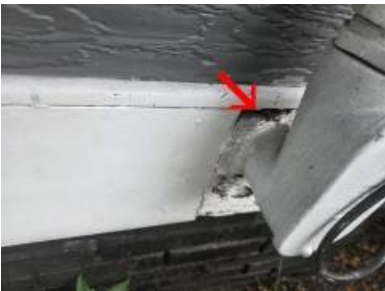
Issues: Holes in siding noted. Water damage noted. Consult a contractor for further evaluation and repair/replacement.

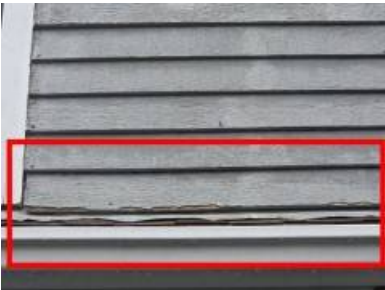
Issues: Damage siding noted. Consult a contractor for further evaluation and repair/replacement.

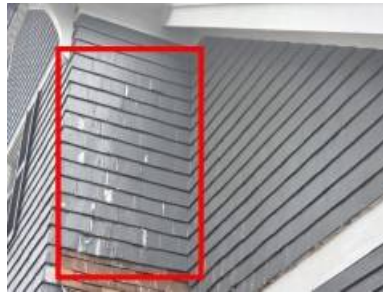
Issues: Peeling paint on siding noted. Consult a contractor for further evaluation and repair/replacement.

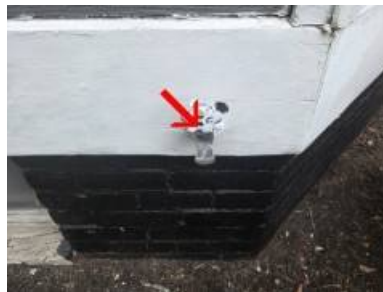
Issues: Hose bib was inoperative. Consult a plumber for further evaluation and repair/replacement.

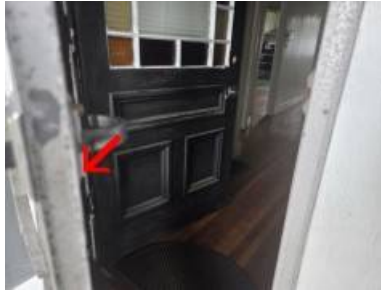
Issues: Screen door has a damaged screen. Consult a contractor for further evaluation and repair/replacement.

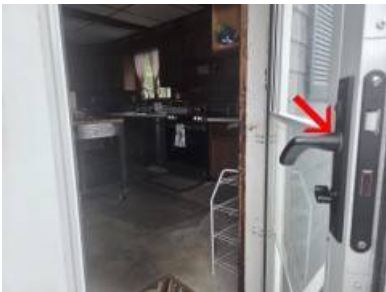
Issues: Screen door installed  
opposite of main door. Consult  
a contractor for further  
evaluation and  
repair/replacement.

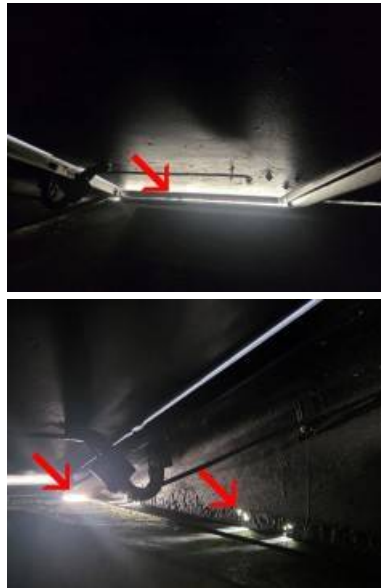
Issues: Gaps/holes are noted. Consult a contractor for further evaluation and repair/replacement.

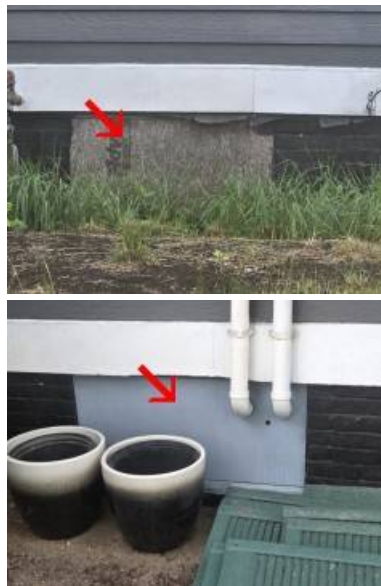
Location: Basement - Issues: Boarded window noted. Consult a contractor for further evaluation and repair/replacement.

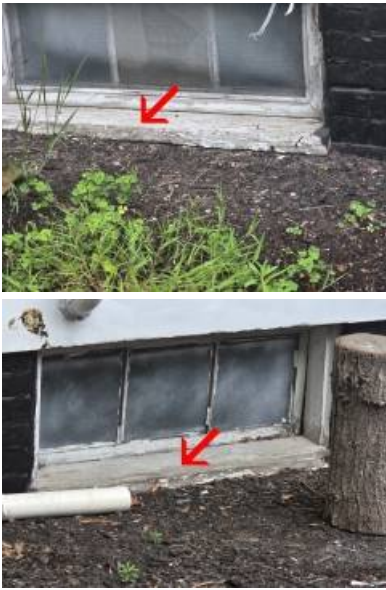
Issues: Peeling paint on sill noted. Consult a contractor for further evaluation and repair/replacement. Earth to wood contact noted. Consult a pest/insect management company.

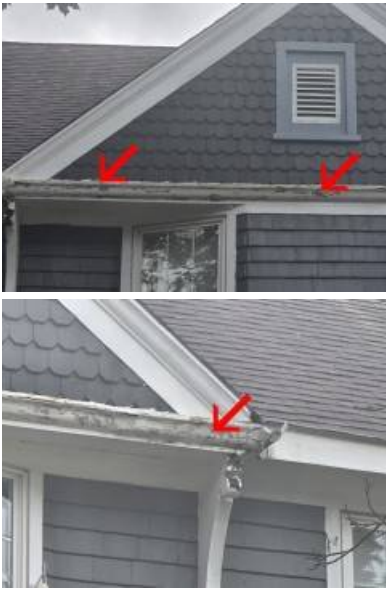
Location: Front, Issues: Peeling paint on fascia noted. Consult a contractor for further evaluation and repair/replacement.

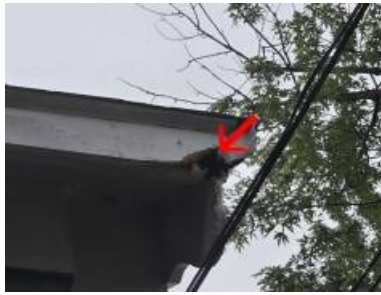
Issues: Water damage noted. Holes in fascia noted. Consult a contractor for further evaluation and repair/replacement.

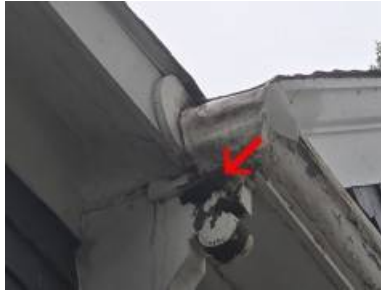
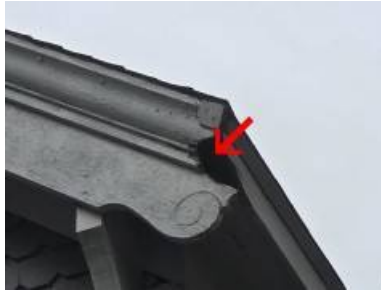
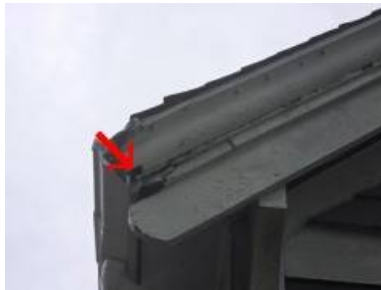
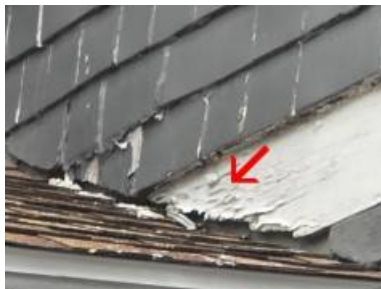
Issues: Water damaged fascia noted. Consult a contractor for further evaluation and repair/replacement.

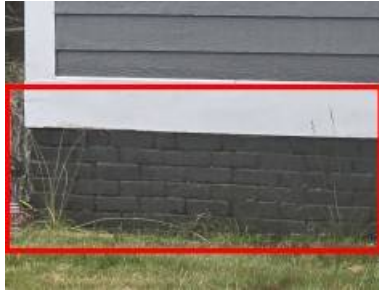
Issues: Deteriorated mortar joints are noted. Re-point to prevent further rainwater entry and ongoing deterioration. Consult a contractor for further evaluation and repair/replacement.

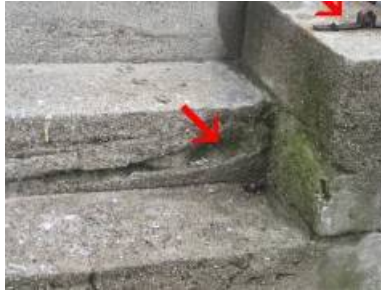
Issues: Damage/deterioration is noted, Consult a contractor for further evaluation and repair/replacement.

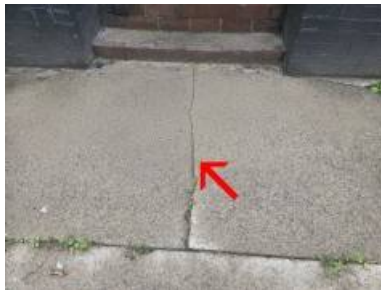
Issues: Cracks noted, Repair needed.

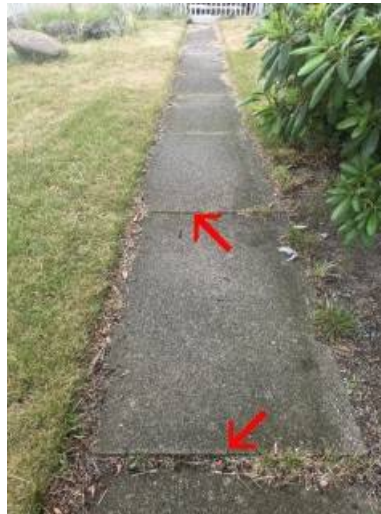
Issues: Surface raised/settled, Tripping hazards, Consult a contractor for further evaluation and repair/replacement.

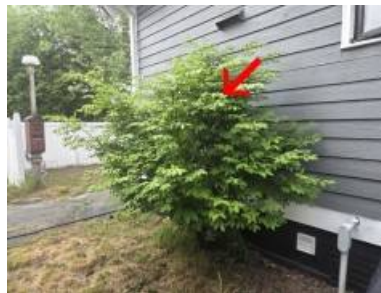
Location: Rear, Issues: Trim plants away from structure.

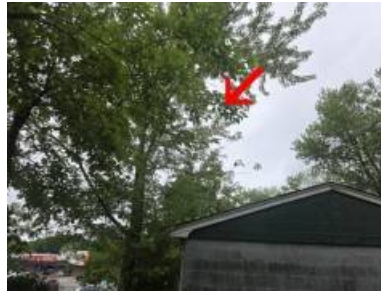
Issues: Tree limbs are overhanging the roof surface and should be trimmed. Consult a contractor for further evaluation and repair/replacement.

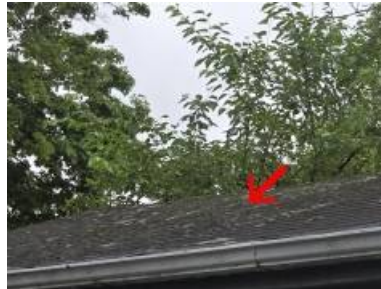
Issues: Moss, mildew and/or mold growth noted. Consult a roofer for further evaluation and repair/replacement.

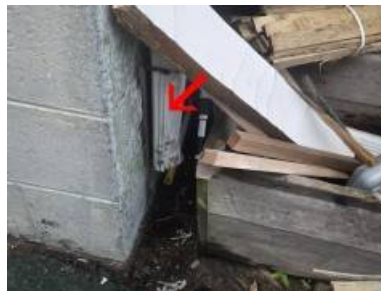
Issues: Extend downspouts to route rainwater away from the building. Gutters are discharging water near the foundation. Consult a contractor for further evaluation and repair/replacement.

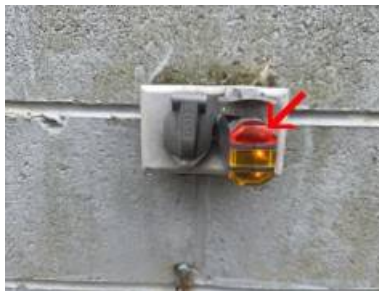
Issues: Ground Fault Circuit Interrupter (GFCI) outlets are recommended for installation at basement, exterior, garage, bath rooms & kitchen outlets. Consult a electrician for further evaluation and repair/replacement.

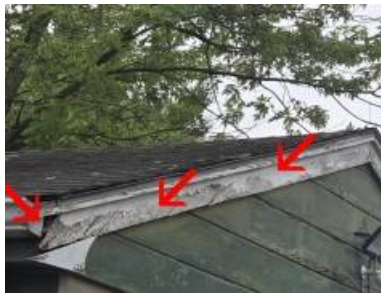
Soffits and overhang materials are painted wood.

Issues: Peeling paint on fascia noted. Water damage noted. Consult a contractor for further evaluation and repair/replacement.

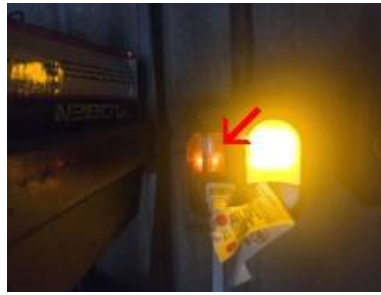
Issues: Ground Fault Circuit Interrupter (GFCI) outlets are recommended for installation at basement, exterior, garage, bath rooms & kitchen outlets. Consult a electrician for further evaluation and repair/replacement.

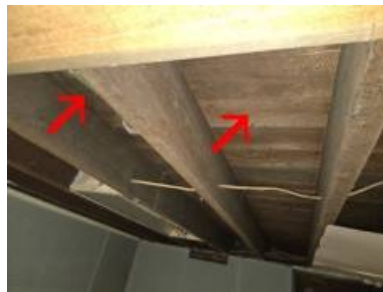
No under floor insulation exists.

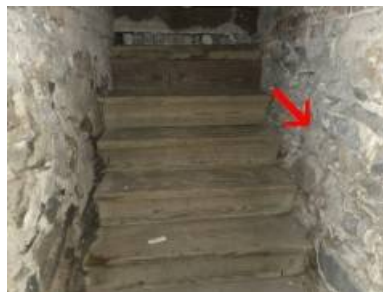
Issues: There is no handrail installed. Consult a contractor for further evaluation and repair/replacement.

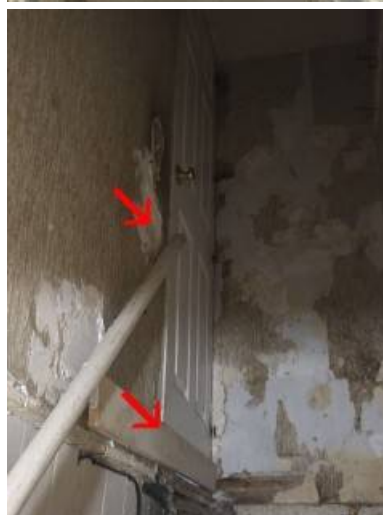
Issues: Missing landing. Handrail does not return to wall at top of stairs and can pose a falling hazard. Consult a contractor for further evaluation and repair/replacement.

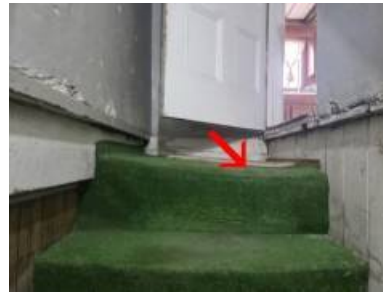
Issues: Sagging noted in stairs, recommend adding extra support. Consult a contractor for further evaluation and repair/replacement.

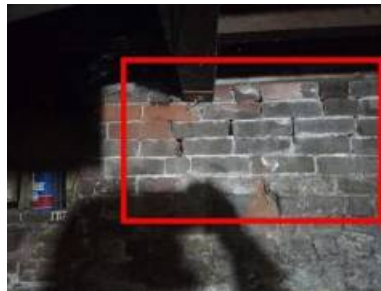
Materials: Walls are brick.

Issues: Deteriorated mortar joints are noted. Re-point to prevent further rainwater entry and ongoing deterioration. Consult a contractor for further evaluation and repair/replacement.

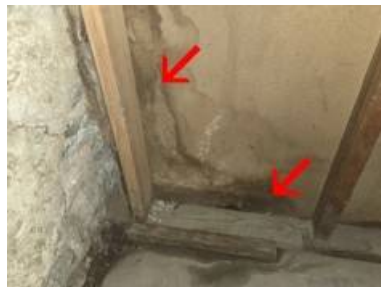
Issues: Staining was observed: Evidence of prior water penetration is noted. A mold/air quality inspection is suggested. Consult a contractor for further evaluation and repair/replacement.

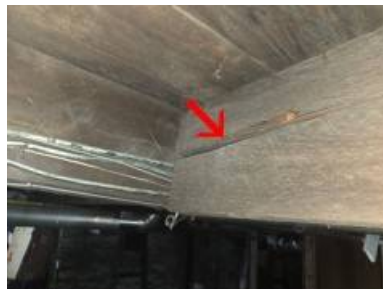
Materials: wood, The main beam is a single large dimension wood board.

Issues: Beam sagging and/or cracked, Consult a contractor for further evaluation and repair/replacement.

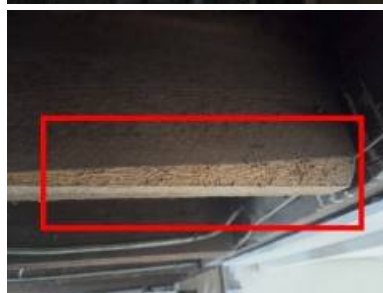
Issues: Possible insect damage noted. Consult a pest/insect management company for further evaluation and repair/replacement.

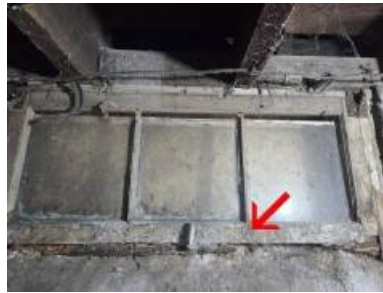
Issues: Broken glass was found. Consult a contractor for further evaluation and repair/replacement.

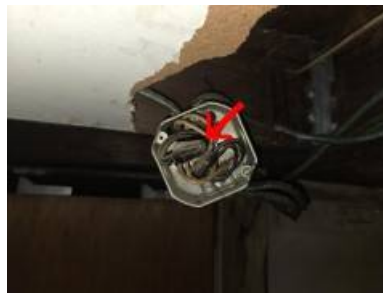
Issues: Junction box cover(s) are missing. Consult a electrician for further evaluation and repair/replacement.

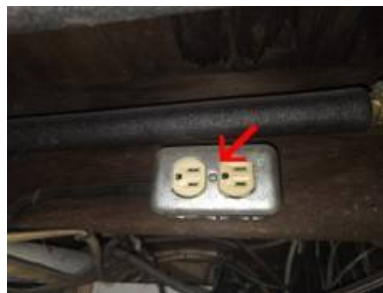
Issues: Ground Fault Circuit Interrupter (GFCI) outlets are recommended for installation at basement, exterior, garage, bath rooms & kitchen outlets. Consult a electrician for further evaluation and repair/replacement.

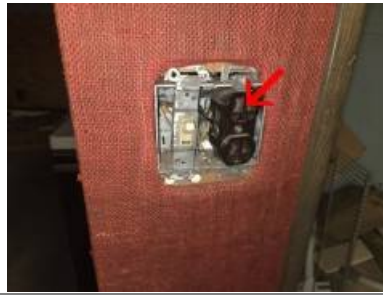
Issues: Outlet cover needs to be replaced. Consult a electrician for further evaluation and repair/replacement.

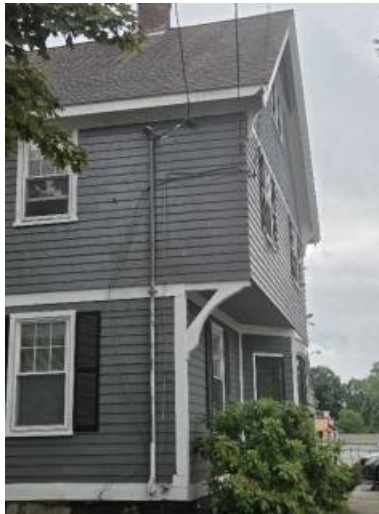
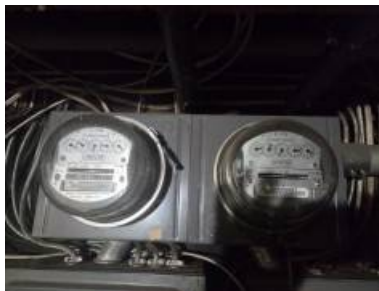
Type: Overhead, 120/240 Volt.

Issues: No common area meter. Check with seller to determine where common area electricity is being billed.

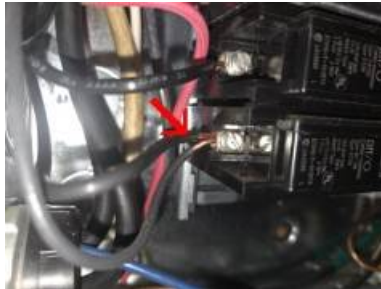
Issues: Multiple wires are  
connected to a single lug on a  
circuit breaker where only one  
wire should be connected,  
Consult a electrician for further  
evaluation and  
repair/replacement.

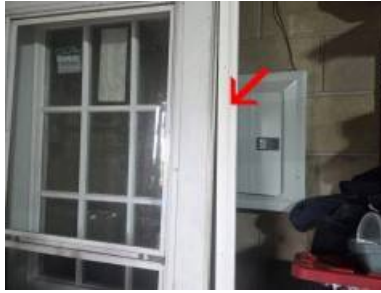
Issues: Panel is obstructed in front as there is not 3' of unobstructed space in front. Panels are without the benefit of complete labeling, Consult a electrician for further evaluation and repair/replacement.

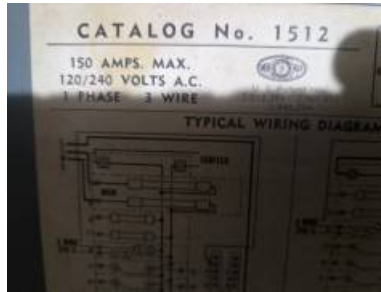
Panel Box Rating: 150 amps.

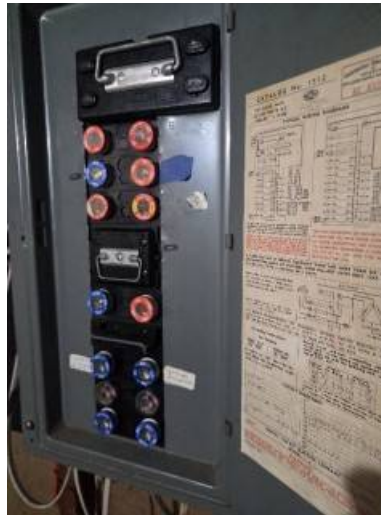
Issues: Panels are without the benefit of complete labeling, Electrical system appears outdated by today's standards. Upgrade should be considered. Consult a electrician for further evaluation and repair/replacement.

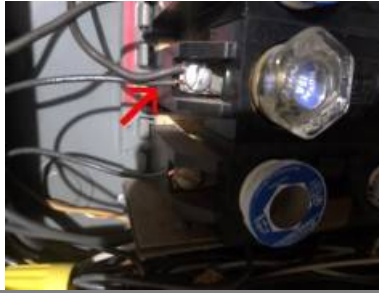
Issues: Multiple wires are connected to a single lug on a circuit breaker where only one wire should be connected, Electrical system appears outdated by today's standards. Upgrade should be considered. Consult a electrician for further evaluation and repair/replacement.

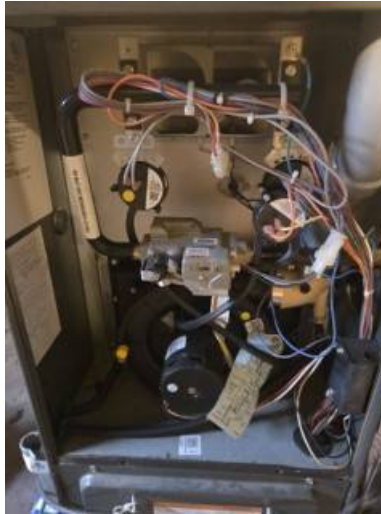
Brand: Goodman Manufacturing brand. Manufacture Date- 2011.

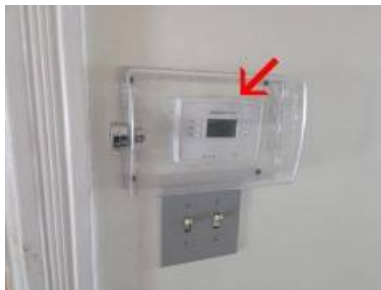
Issues: Locked thermostat cover no access to check heat function. Consult seller and/or a hvac technician for further evaluation and repair/replacement.

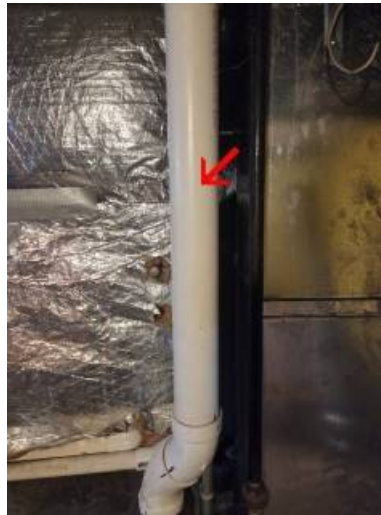
Types: The flue pipe is plastic from the furnace to the exterior.

Issues: Improper materials in vent, Consult a hvac technician for further evaluation and repair/replacement.

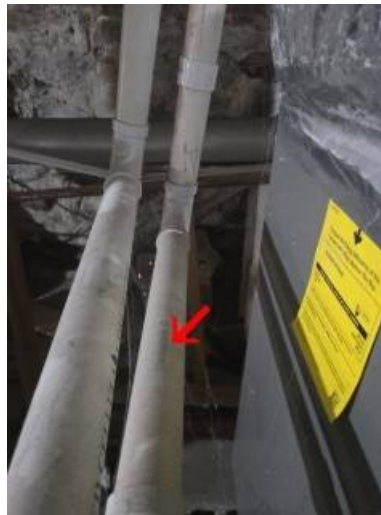
Types: The flue pipe is plastic from the furnace to the exterior.

Issues: Improper materials in vent. Consult a hvac technician for further evaluation and repair/replacement.

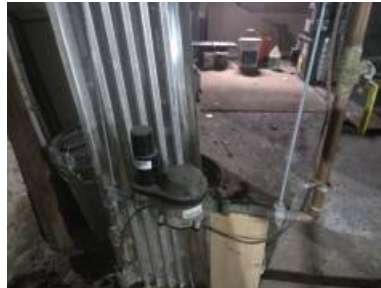
Main Shutoff Valve, was not tested.

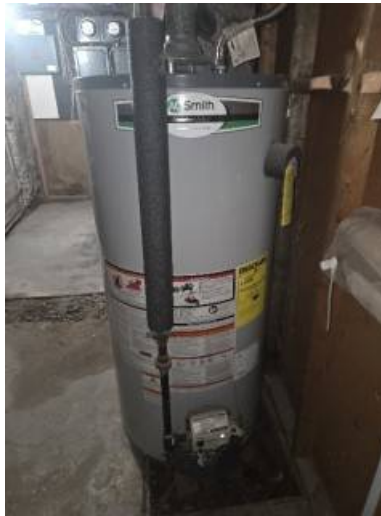
Capacity: 40 Gallons, Types:  
Tank system, 2014.

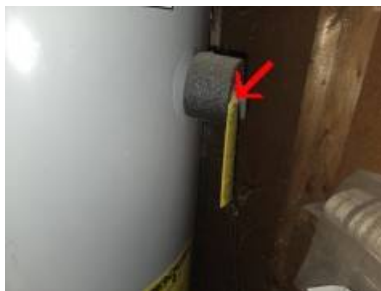
Issues: No pressure relief valve  
is installed (RECOMMENDED),  
Consult a plumber for further  
evaluation and  
repair/replacement.

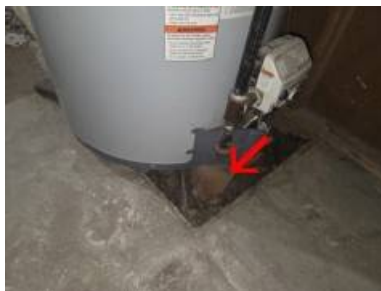
Issues: Recommend proper base  
for water heater. Consult a  
contractor for further evaluation  
and repair/replacement.

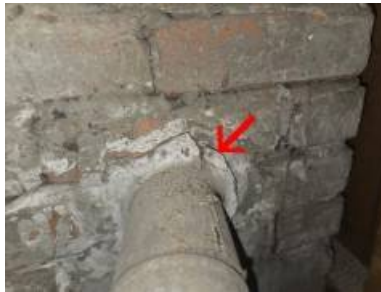
Issues: No thimble installed on vent pipe connection to chimney. Consult a plumber for further evaluation and repair/replacement.

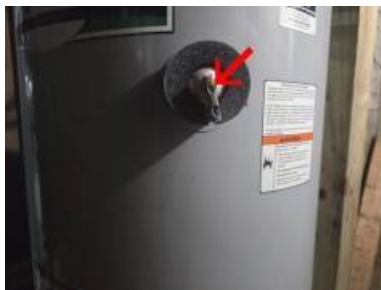
Issues: No pressure relief valve is installed (RECOMMENDED), Consult a plumber for further evaluation and repair/replacement.

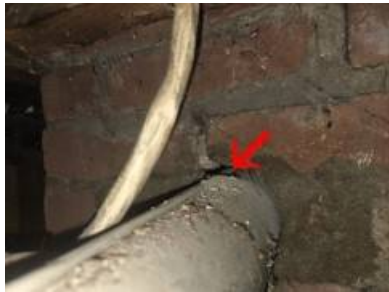
Issues: No thimble installed on vent pipe connection to chimney. Improper venting is noted, Flue for water heater is loose from the chimney. Consult a contractor for further evaluation and repair/replacement.

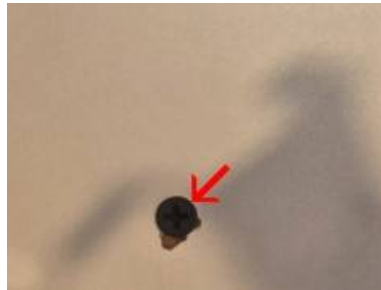
Issues: Wall cabinets are installed with improper fasteners. Replacement with proper fasteners is recommended. Consult a contractor for further evaluation and repair/replacement.

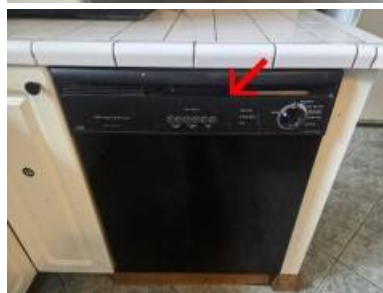
Issues: Not operational, Consult a plumber for further evaluation and repair/replacement.

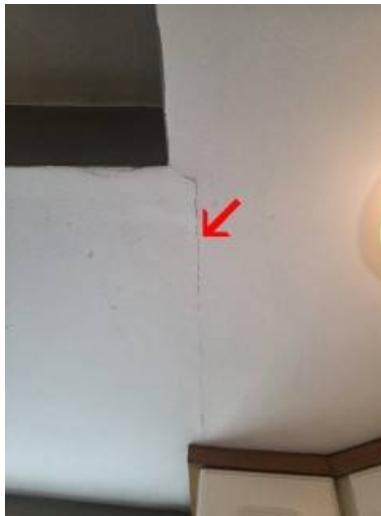
Issues: Cracks/holes noted. Consult a contractor for further evaluation and repair/replacement.

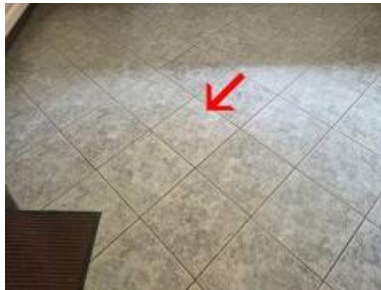
Issues: Noted uneven floor due to settlement. Consult a contractor for further evaluation and repair/replacement.

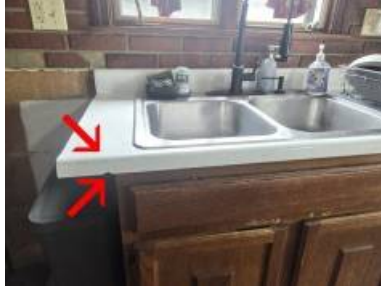
Issues: Countertop is loose and damaged. Consult a contractor for further evaluation and repair/replacement.

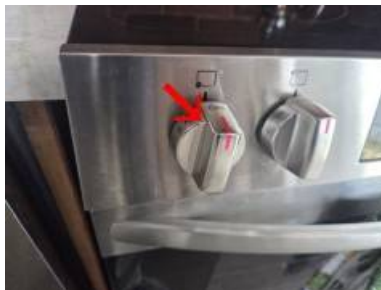
Issues: Range burner is inoperative, Oven bake element is inoperative, Control knobs or panel is damaged/missing, Consult a contractor for further evaluation and repair/replacement.

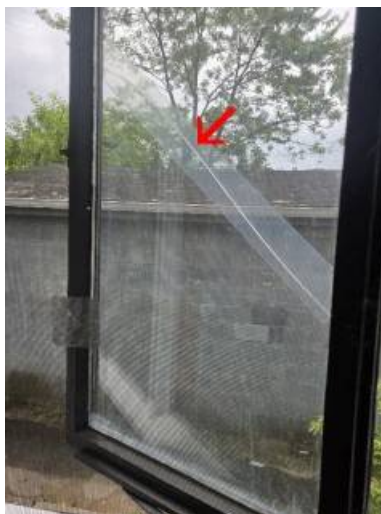
Issues: Broken glass was found. The seal on the insulated windows are broken on some windows. This indicates that the windows are not energy efficient and should be repaired or replaced. Consult a contractor for further evaluation and repair/replacement.

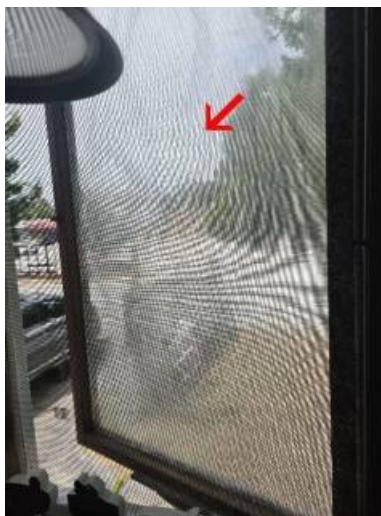
Issues: The seal on the insulated windows are broken on some windows. This indicates that the windows are not energy efficient and should be repaired or replaced. Consult a contractor for further evaluation and repair/replacement.

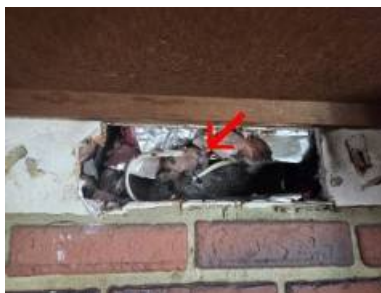
Issues: Opening noted. Consult a contractor for further evaluation and repair/replacement.

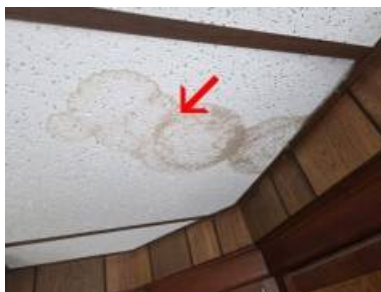
Issues: There is evidence of an unrepaired stain on the ceiling caused by a prior moisture leak. Consult a contractor for further evaluation and repair/replacement.

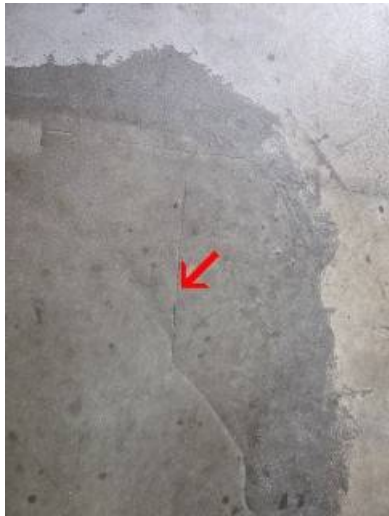
Issues: Damage/deterioration is noted. Consult a contractor for further evaluation and repair/replacement.

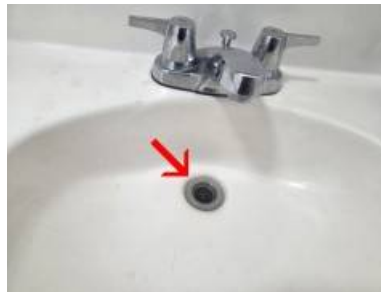
Issues: The following problems were noted at the drain: Stopper did not operate properly. Consult a plumber for further evaluation and repair/replacement.

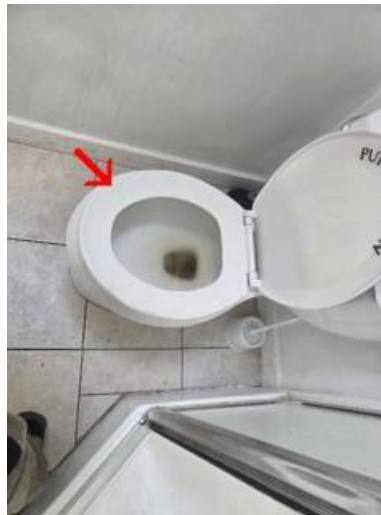
Issues: Toilet does not flush properly and needs repair. Consult a plumber for further evaluation and repair/replacement.

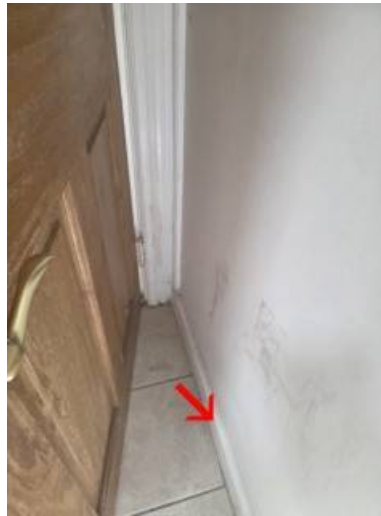
Issues: No door stop installed. Consult a contractor for further evaluation and repair/replacement.

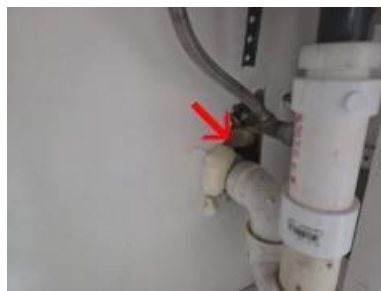
Issues: There are holes in wall near pipes that should be sealed. Consult a contractor for further evaluation and repair/replacement.

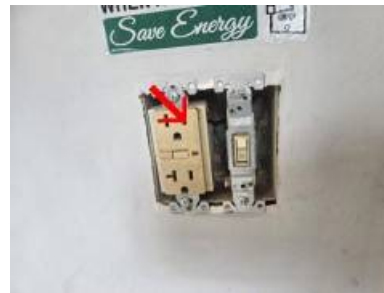
Issues: Switch cover needs to be replaced. Consult a electrician for further evaluation and repair/replacement.

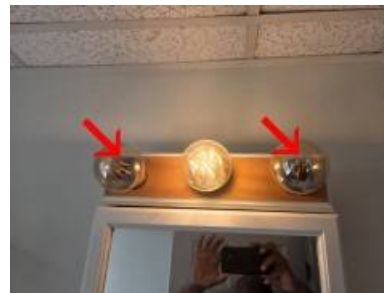
Issues: The light installed in this room did not function using the wall switch. I did not determine if the switch is bad or if the light bulb is bad. Consult a electrician for further evaluation and repair/replacement.

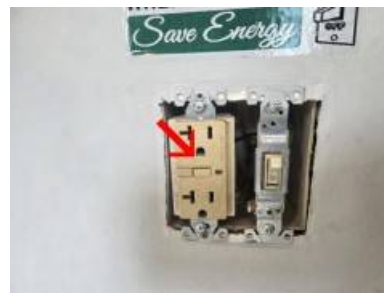
Issues: Outlet cover needs to be replaced. Consult a electrician for further evaluation and repair/replacement.

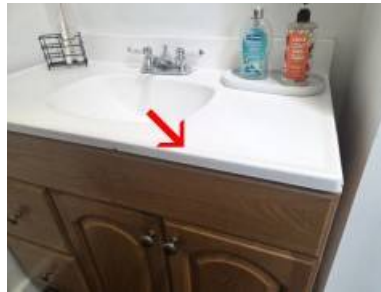
Issues: Countertop is loose. Consult a contractor for further evaluation and repair/replacement.

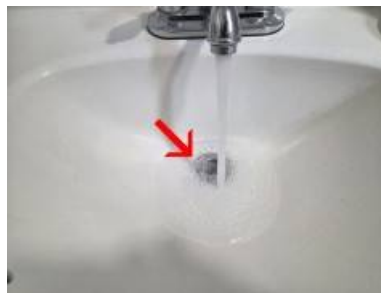
Issues: The following problems were noted at the drain: Stopper did not operate properly. Consult a plumber for further evaluation and repair/replacement.

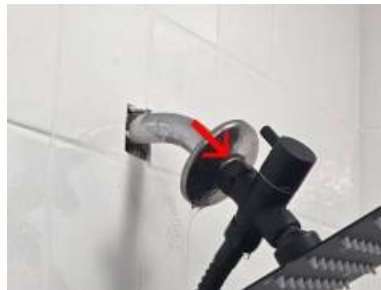
Issues: Condition of showerhead: Shower head is leaking, Consult a plumber for further evaluation and repair/replacement.

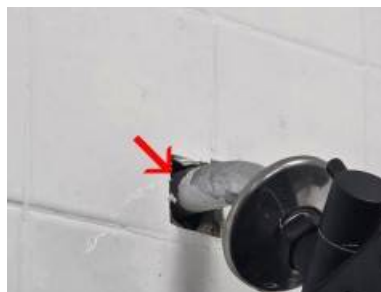
Issues: Damage and Deterioration is noted. Consult a contractor for further evaluation and repair/replacement.

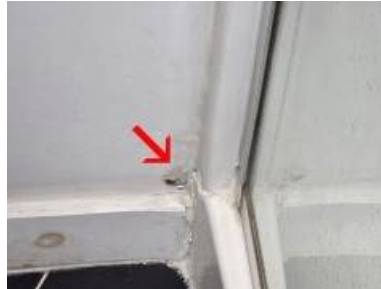
Issues: There is evidence of an unrepaired stain on the wall caused by a prior moisture leak. Consult a contractor for further evaluation and repair/replacement.

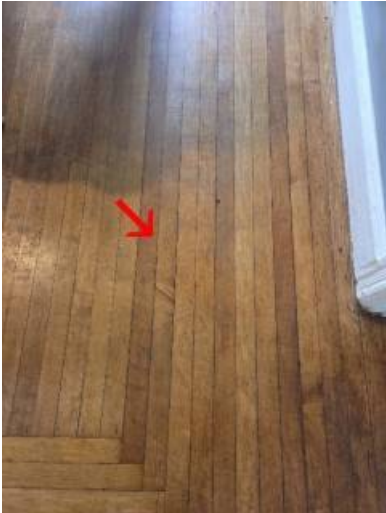
| F | M | NF | SH | NA/<br>NI | | |
|---|---|---|---|---|---|---|
| | | | | | Floors Issues: | <br>Issues: Noted uneven floor due to settlement. Consult a contractor for further evaluation and repair/replacement. |

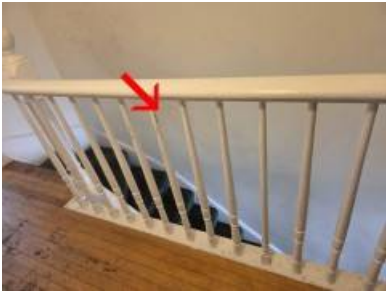
| F | M | NF | SH | NA/<br>NI | | |
|---|---|---|---|---|---|---|
| | | | | | Stairs & Handrails Issues: | <br>Issues: Handrail is too low. Consult a contractor for further evaluation and repair/replacement. |

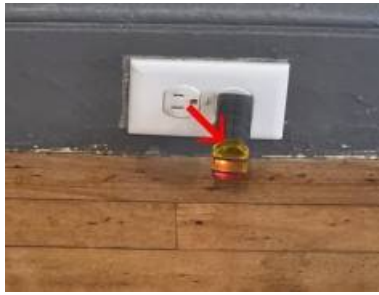
Issues: Wiring of outlet is not correct. There is a Hot/Neutral Reversed. Consult a electrician for further evaluation and repair/replacement.

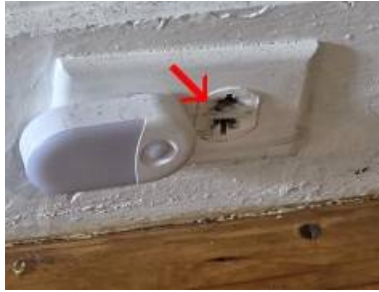
Issues: Some grounded type outlets did not appear to be properly grounded. The electrical system is an older non-grounded 2-wire system. Due to safety concerns, it is suggested client consider upgrading to a new 3-wire grounded system with GFCI protection.

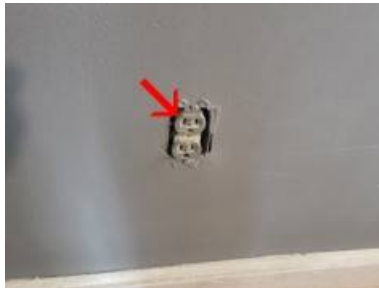
Issues: Outlet cover needs to be replaced. Consult a electrician for further evaluation and repair/replacement.

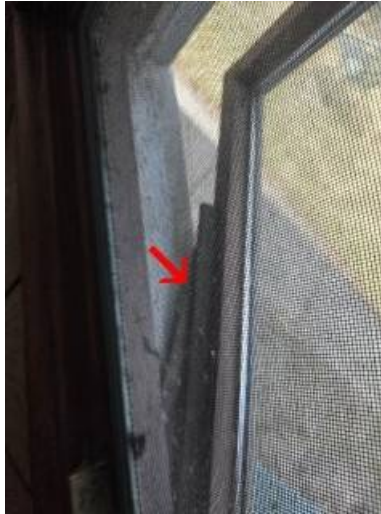
Issues: The handle or opening mechanism for the window is missing/damaged.. Consult a contractor for further evaluation and repair/replacement.

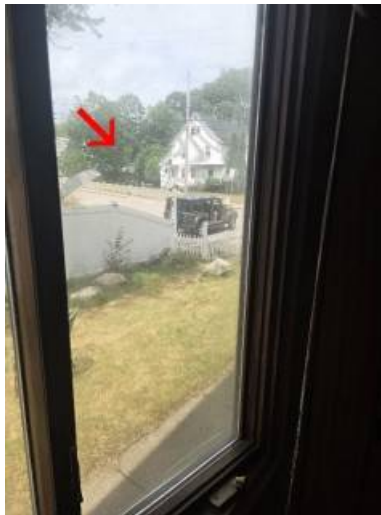
Issues: The seal on the insulated windows are broken on some windows. This indicates that the windows are not energy efficient and should be repaired or replaced. Consult a contractor for further evaluation and repair/replacement.

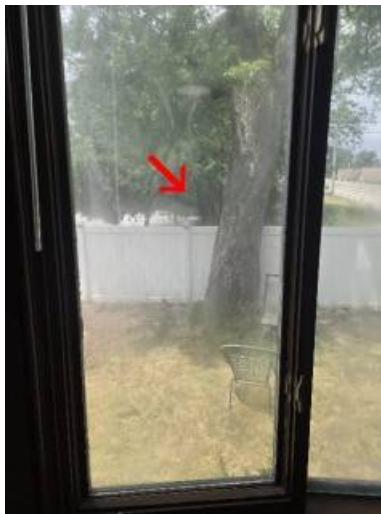
Issues: Window is not functional. Consult a contractor for further evaluation and repair/replacement.

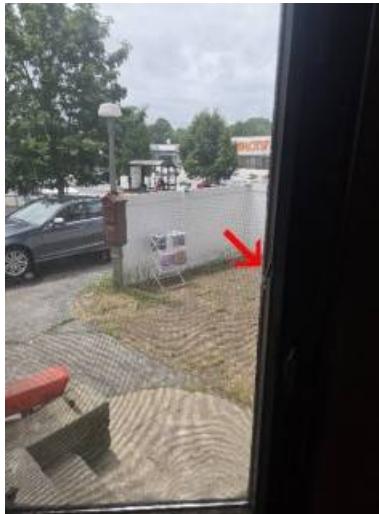
Issues: The latch needs to be adjusted so that the window will latch correctly. Consult a contractor for further evaluation and repair/replacement.

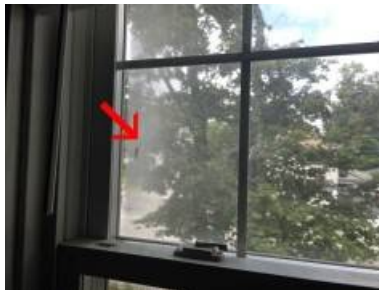
Issues: The seal on the insulated windows are broken on some windows. This indicates that the windows are not energy efficient and should be repaired or replaced. Consult a contractor for further evaluation and repair/replacement.

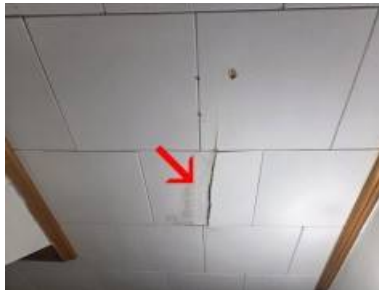
Issues: Cracks/holes noted. Asbestos like ceiling panels located in rooms. Consult a contractor for further evaluation and repair/replacement.

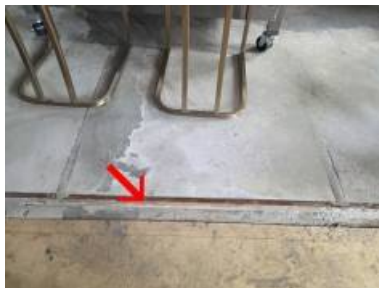
Issues: Threshold is too high and is a tripping hazard. Consult a contractor for further evaluation and repair/replacement.

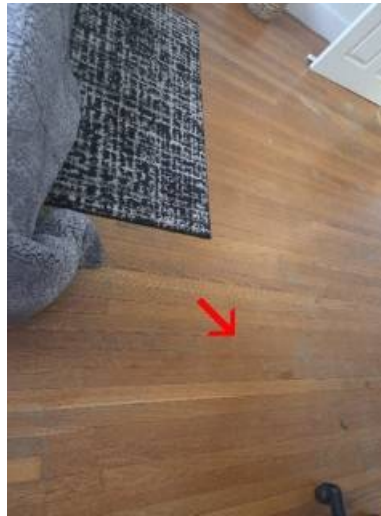
Issues: Noted uneven floor due to settlement. Consult a contractor for further evaluation and repair/replacement.

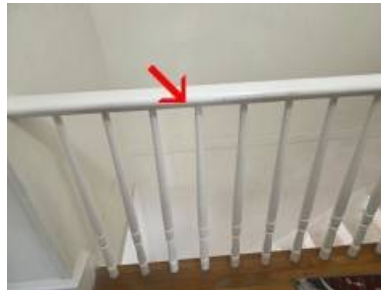
Issues: Handrail is too low. Consult a contractor for further evaluation and repair/replacement.

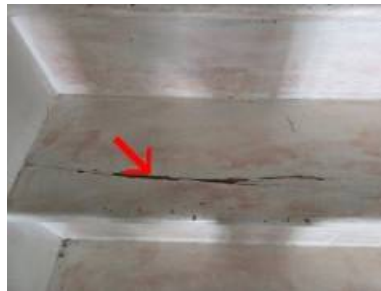
Issues: Stairs have damaged tread(s). Consult a contractor for further evaluation and repair/replacement.

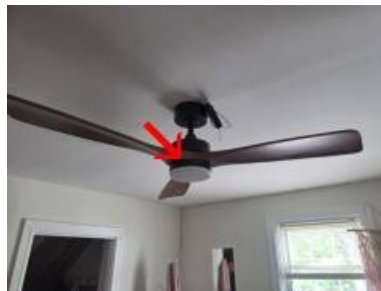
Issues: The light installed in this room did not function using the wall switch. I did not determine if the switch is bad or if the light bulb is bad. Consult a contractor for further evaluation and repair/replacement.

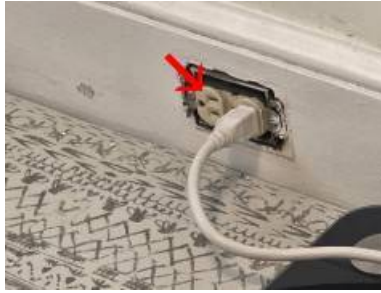
Issues: Outlet cover needs to be replaced. Consult a electrician for further evaluation and repair/replacement.

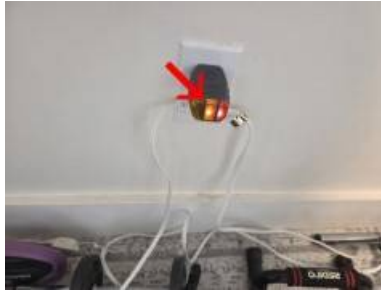
Issues: Wiring of outlet is not correct. There is a Hot/Neutral Reversed. Consult a electrician for further evaluation and repair/replacement.

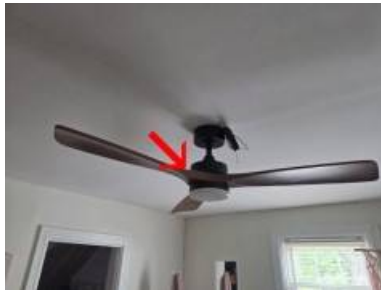
Issues: The ceiling fan installed in this room did not function using normal controls. Consult a contractor for further evaluation and repair/replacement.

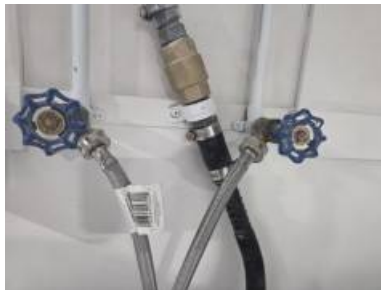
Issues: Drain lines and water supply valves serving washing machines are not operated.

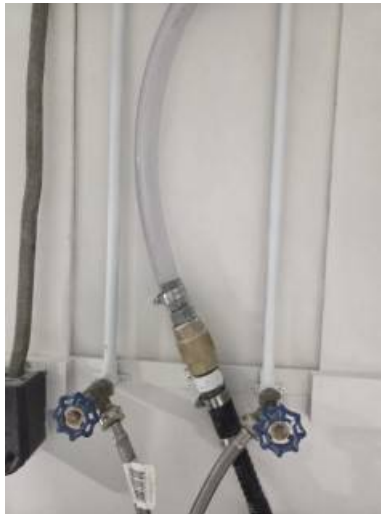
Issues: Drain lines and water  
supply valves serving washing  
machines are not operated.

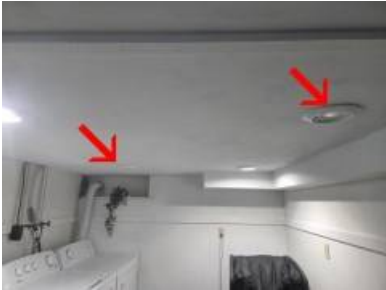
Issues: The light installed in this room did not function using the wall switch. I did not determine if the switch is bad or if the light bulb is bad. Consult a electrician for further evaluation and repair/replacement.
